**US Army Corps
of Engineers**
Louisville District

**Banklick Creek Watershed
Kenton County, Kentucky
Flood Damage Reduction / Ecosystem Restoration
Section 905(b) (WRDA 1986) Analysis**

September, 2000

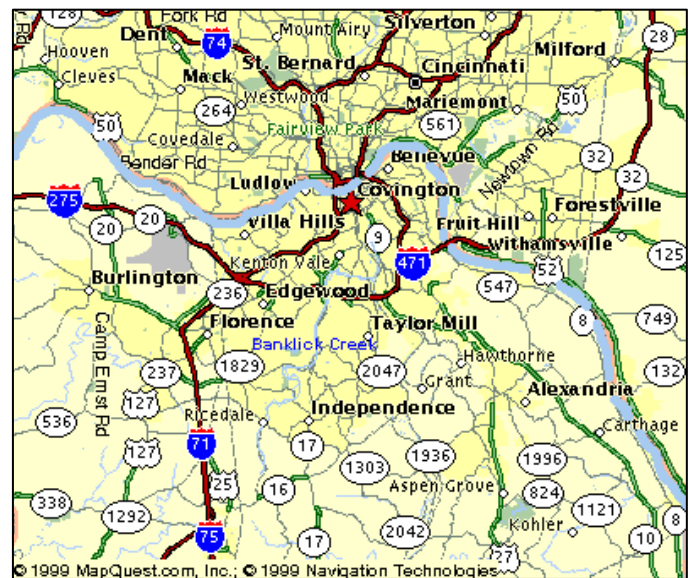
Figure 1: Vicinity Map (Northern Kentucky)

The entire study area lies within Kentucky Congressional District 4. Kenton County has a population of approximately 149,000. Section 14 (Figure 29, page 41) of this report contains a general location and vicinity map of the study area. Figure 1 (below) is a vicinity map of Northern Kentucky.

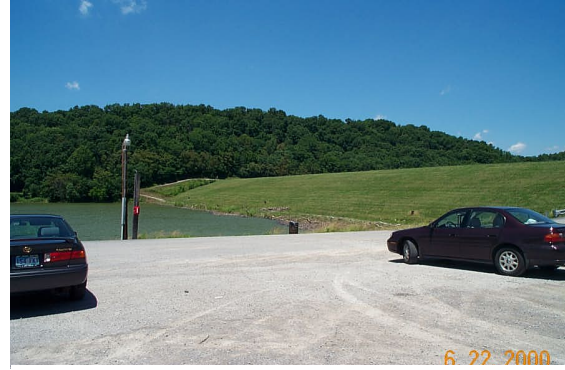
Figure 2: Dam # 3 on Bullock Pen Creek

One of the recommended structures, Dam No. 3, on Bullock Pen Creek has been constructed (shown in Figure 2).

Doe Run Lake (Dam No. 3) was constructed by the U.S. Soil Conservation Service on Bullock Pen Creek, a Banklick Creek tributary, to reduce flood peaks downstream of this facility (See Figure 6.) Total storage capacity is approximately 2500 acre-feet.

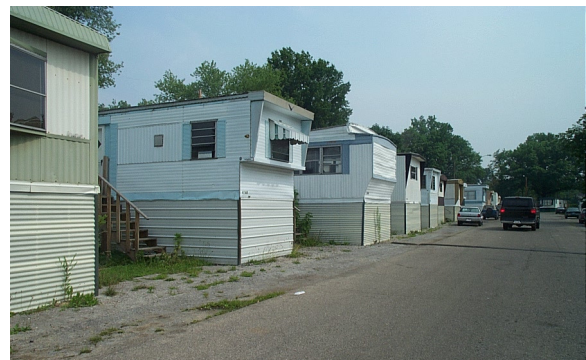
Figure 3: Elevated Mobile Homes

Apparently, as a result of this report, the mobile homes have subsequently been elevated above most major flood levels (shown in Figure 3).

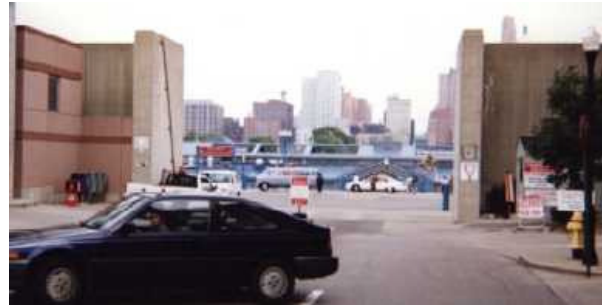
Figure 4: Traffic Closures

Covington Local Protection Project which includes 1.8 miles of earthen levees, 1.1 miles of concrete wall, 10 pumping stations and 8 traffic closures is shown in Figures 4 and 5. The project was completed in 1965 and protects approximately 400 acres.

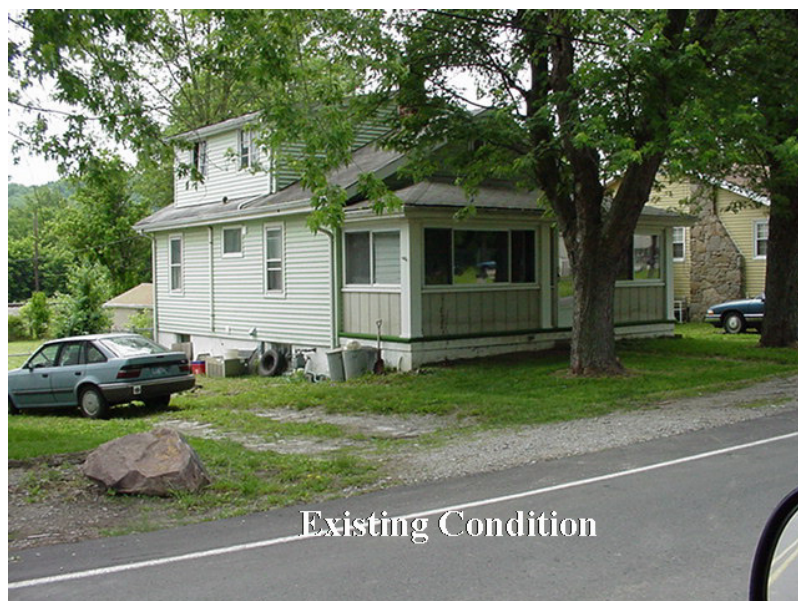
The only method of flood proofing that will ensure complete safety from flood damage is relocating the building to a site outside of the flood plain. The buy-out option (See Figures 11 & 12) was selected for structures estimated to be within the floodway or where flooding depths are estimated to exceed three feet. According to The Blue Book, approximately 50% of those interviewed were interested in this option. Data compiled by the Public Valuation Administrator included property values. A nominal value of \$75,000 per recommended buy-out structure was chosen.

Figure 11: Example of Buy-out existing condition

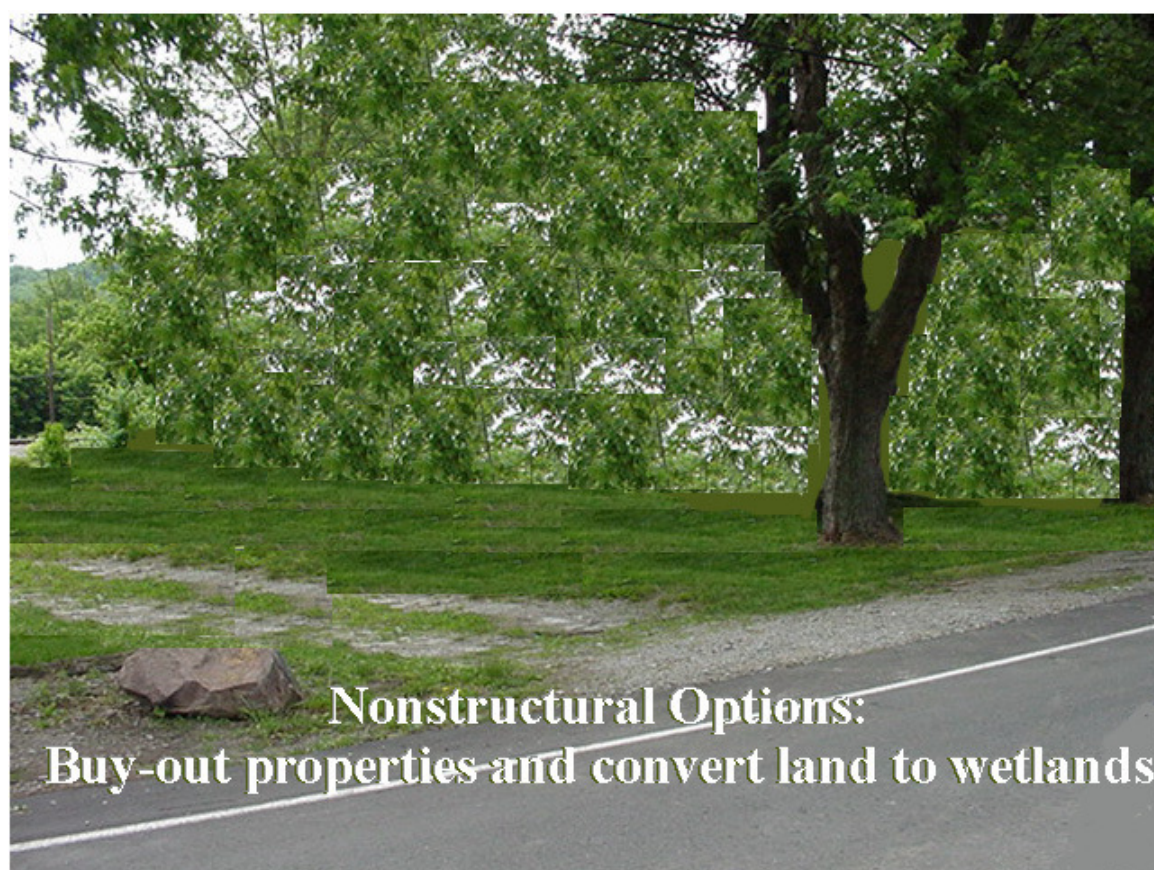
Figure 12: Example of Buy-out modified condition

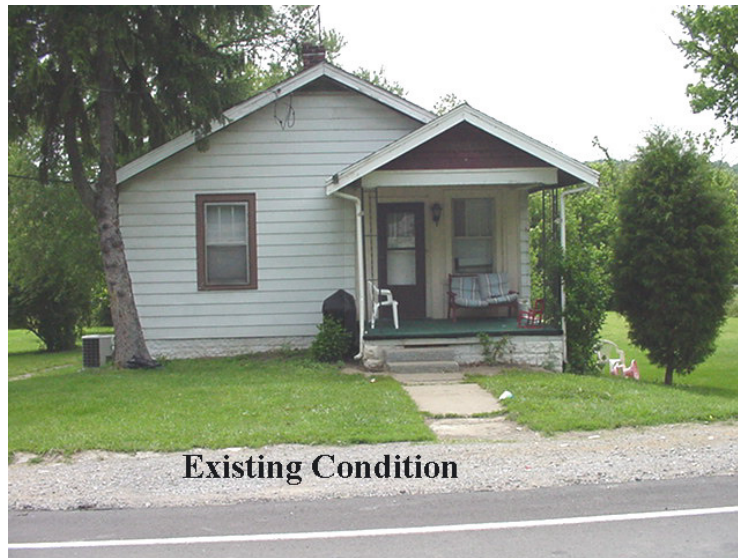
Figure 13: Example of Raise-in-place existing condition

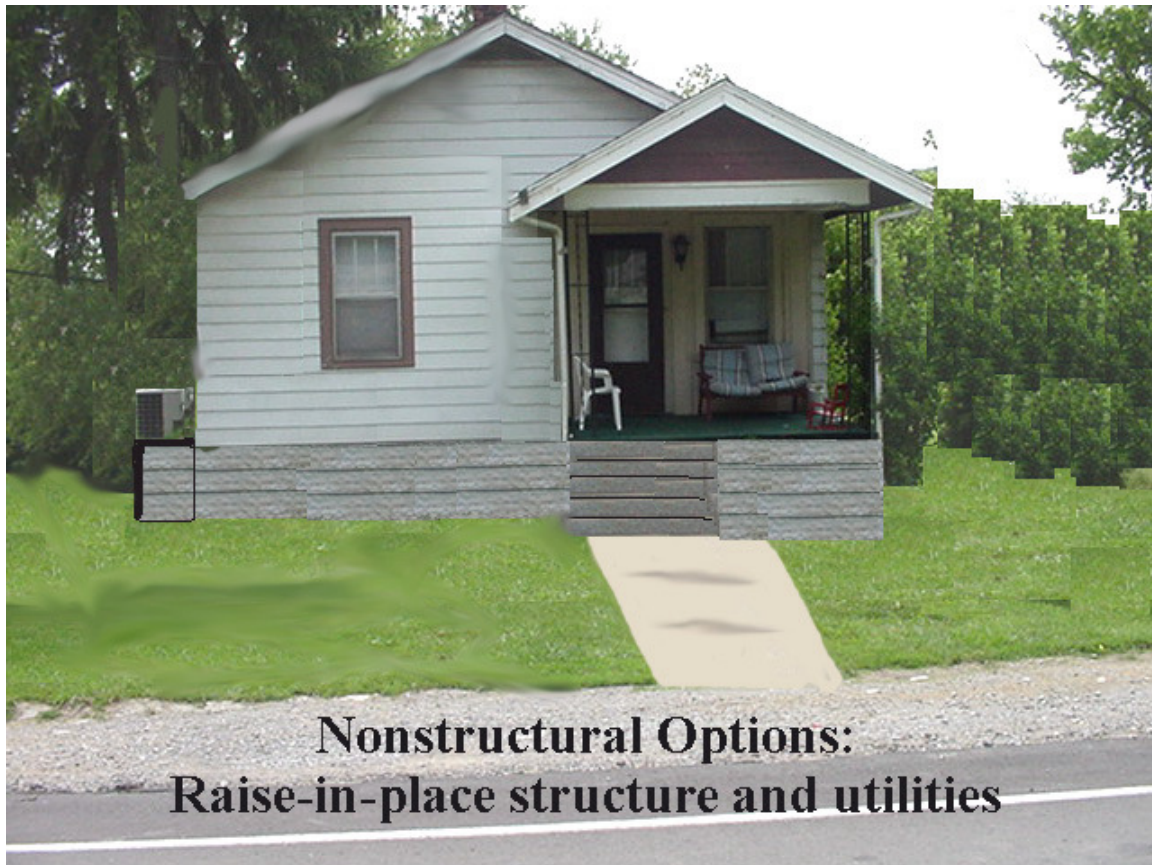
Figure 14: Example of Raise-in-place modified condition

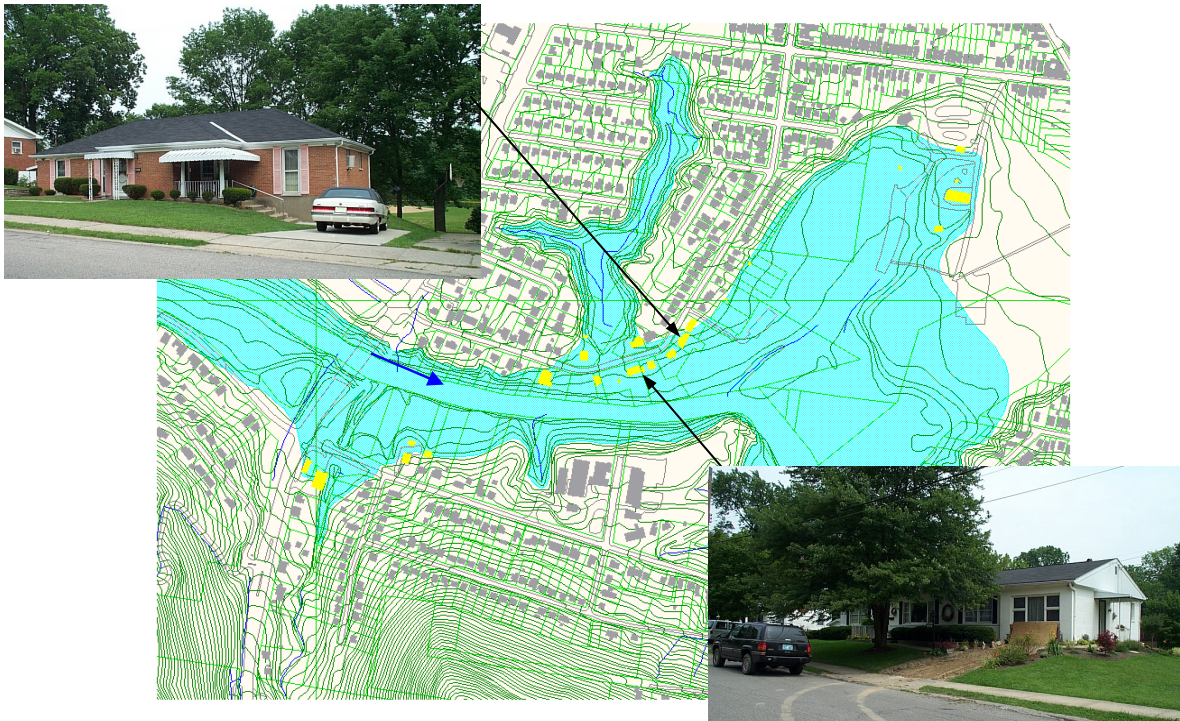
Figure 15: Damage Area 1 and Associated Structures

Damage Area 1 is shown in Figure 15. Damages in this area are primarily associated with homes along Church Street and Grand Avenue located near the center of the figure. The cause of flooding is a combination of backwater from the Ohio and Licking Rivers and headwater flooding from Banklick Creek. Flood proofing measures are recommended to protect these structures. The estimated cost for flood proofing this damage area is \$82,800.

Note: The area in the damage area sitemaps displayed in blue represents the floodplain as provided with the GIS coverages. The floodplain is based on the current FEMA floodplain delineation.

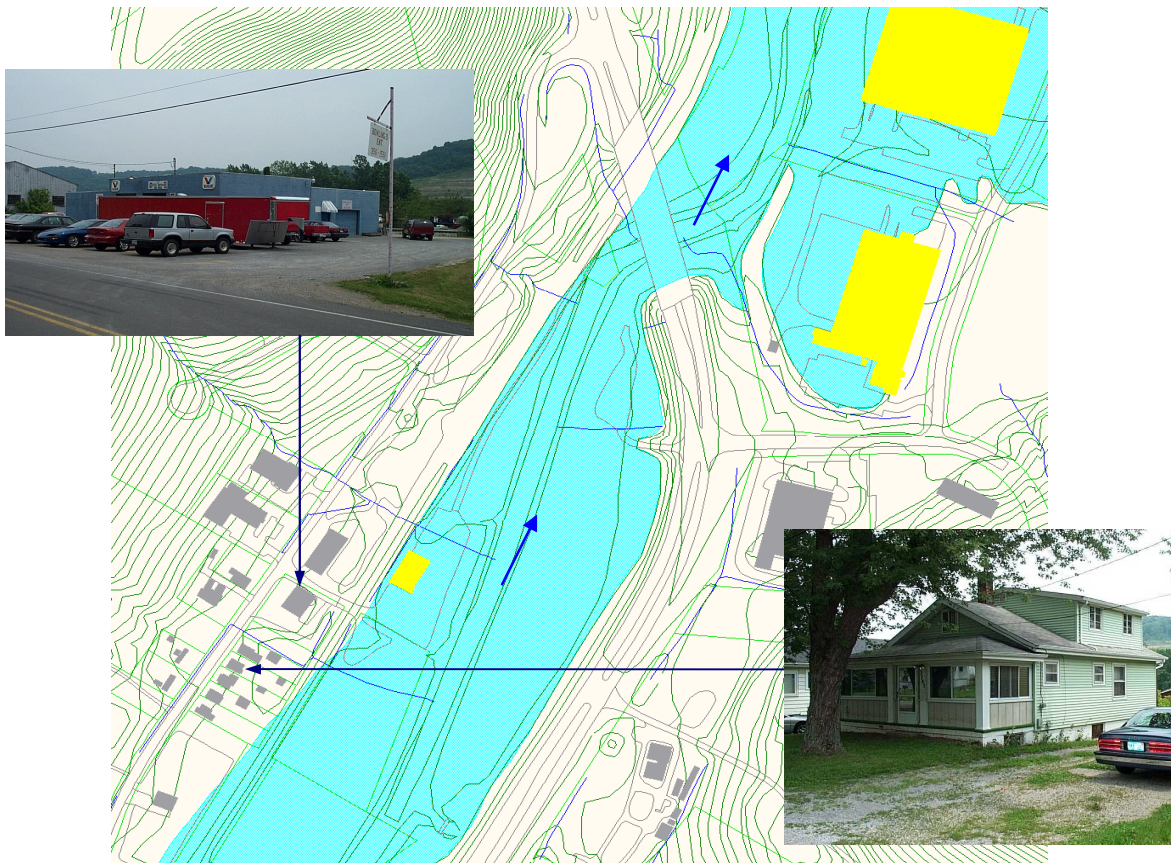
Figure 16: Damage Area 2 and Associated Structures

Damage Area 2 is shown in Figure 16. Damages in this area are primarily associated with homes along Old Kentucky 17 (Old Madison Pike). The floodplain shown does not accurately reflect flooding in this area. Homes in the southeast corner of Figure 16 have experienced severe flooding damages during significant rainfall events. Examples of floodprone structures are shown. Based on current information, ten structures representing both homes and businesses would be impacted by the 1% flood.

For purposes of this study, the estimated costs include buy-out, flood proofing and ring walls as alternatives considered depending on the projected potential depth and frequency of flooding. This area should be carefully reevaluated during the Feasibility Study to determine the potential effect on flood elevations of the fill in the left (west) floodplain just downstream from this damage area.

The estimated cost for nonstructural alternatives in Damage Area 2 is \$573,300.

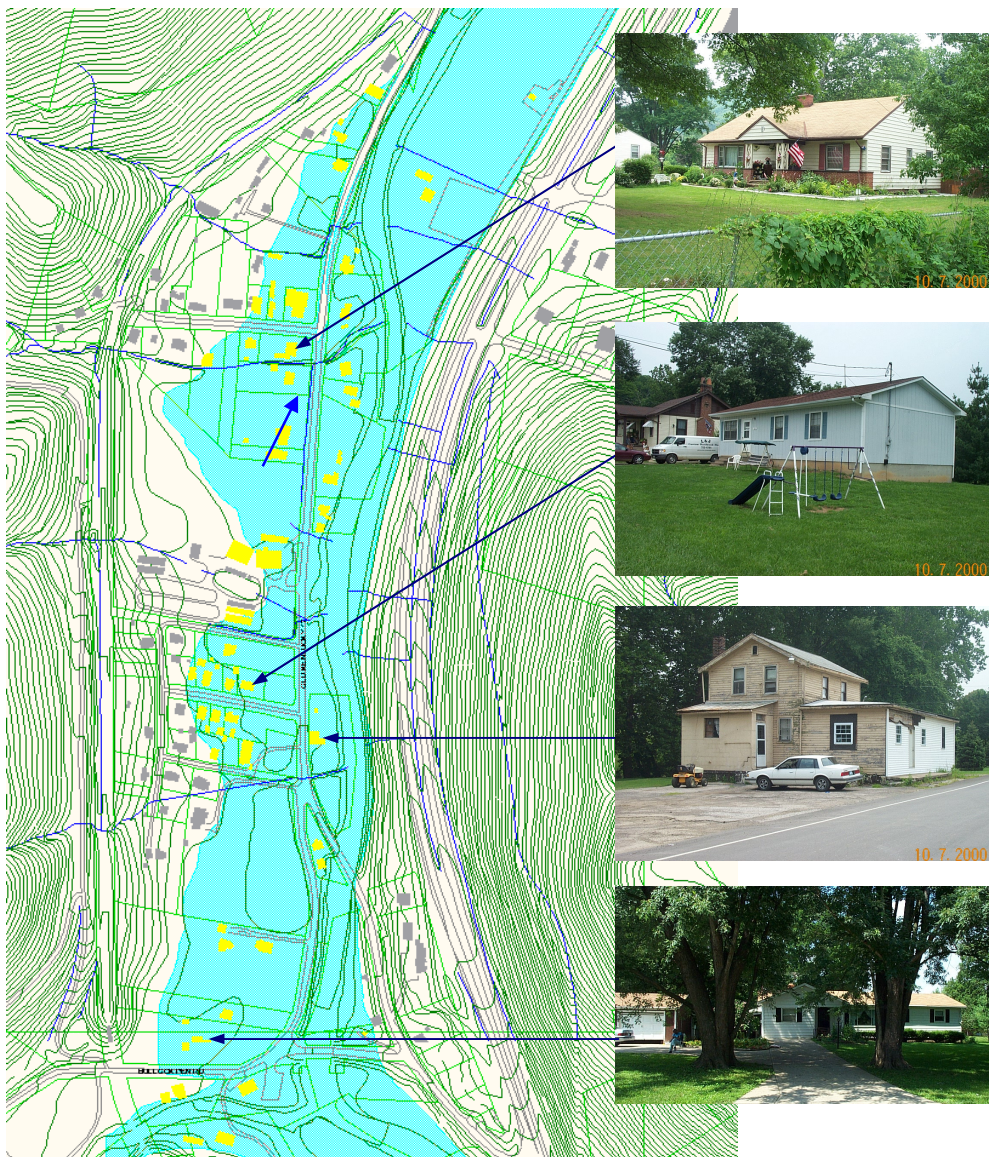
Figure 17: Damage Area 3 and Associated Structures

Damage Area 3 is shown in Figure 17 and represents the area between the railroad underpass and Bullock Pen Road. Damages in this area are primarily associated with homes along Old Kentucky 17. Recent flooding in this area is more severe and frequent than depicted in the current FEMA Flood Insurance Study. Examples of floodprone structures are shown below.

The \$1,383,500 estimated cost includes buy-out, flood proofing or raise-in-place of 38 structures.

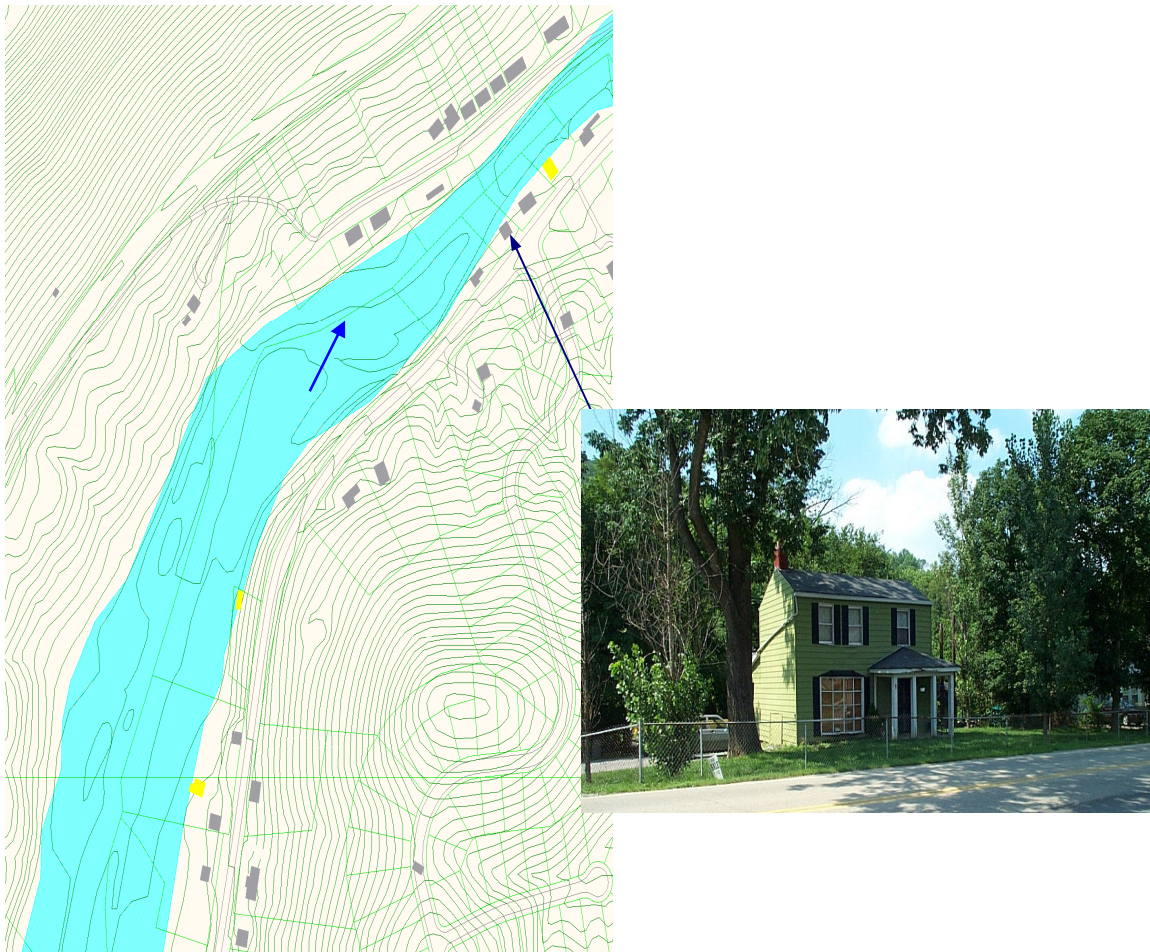
Figure 18: Damage Area 4 and 286 Madison Pike

Damage Area 4 is shown in Figure 18. Damages in this area are associated with homes along Madison Pike and Pleasure Isle Drive. The floodplain shown does not accurately reflect flooding in the area. Based upon field observations and flood information included in *The Blue Book*, the FEMA floodplain is not representative of existing conditions. Examples of floodprone structures are shown. The structures on Pleasure Isle Drive located in the upper right-hand portion of the figure were damaged by floods in the past. The structure shown, located at 286 Madison Pike, reportedly experienced first floor flooding in excess of 4 feet.

Sixteen homes were evaluated for buy-out, raise-in-place, or flood proofing. The estimated cost for this Damage Area is \$454,300.

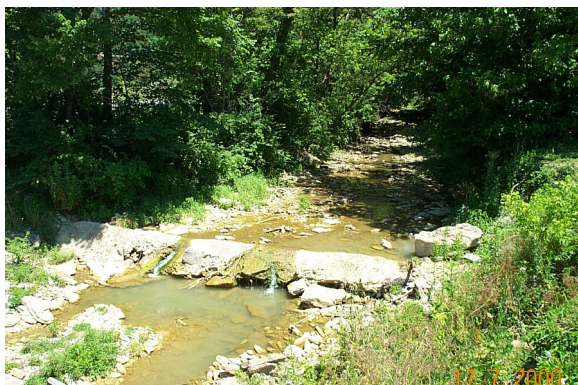
Figure 21: Four Foot Headcut at Mouth of Wayman Creek

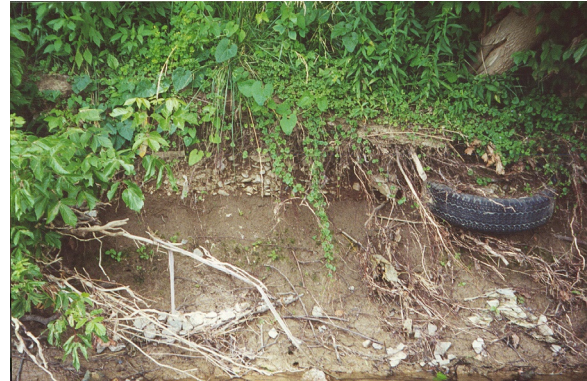
Figure 22: Evidence of Bed Degradation

Evidence of bed degradation up to four feet in recent years can be seen in Figure 22 where a tire was found in a layer of gravel that formerly composed the streambed but now is above bankfull elevation. Several gravel layers can be found in the banks, indicating that at least two series of headcuts (bed degradation) have occurred in recent history, both having lowered the bed approximately two feet. Bed degradation along this reach tends to cause aggradation at the confluence with the Licking River, as is evidenced by the need for frequent dredging activities at this location to promote safe boating conditions. Dredging costs are estimated to be on the order of \$25,000 per year.

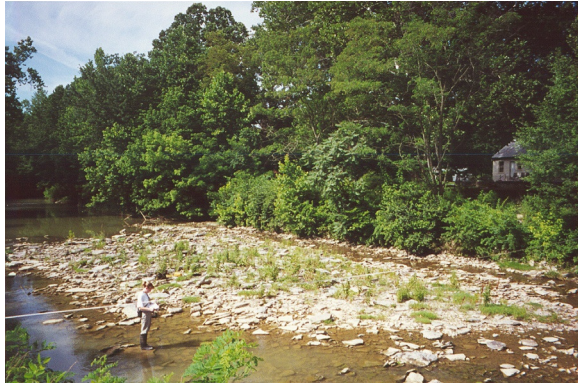
**Figure 23: Cross-Section Near Damage Area
2**

Although bed degradation tends to cause bank erosion (as the stream seeks to increase its sinuosity in response to the increased gradient), the majority of stream banks along Banklick Creek are relatively stable. Throughout Banklick Creek, several areas along the channel have been cleared of the natural riparian buffer that tends to stabilize the banks (see figure 23) and localized erosion has occurred. Other eroded areas are due to the localized downwelling and vortex effects caused around constrictions such as bridge crossings and valley hingements, along with sharp bends caused by channelization. Access to these eroded areas is limited, accordingly, treatments that require minimal disturbance such as live staking should be considered in these areas. Near the mouth of Banklick Creek, the channel banks are much steeper and higher. In this area, there is a need to be wary of potential landslide-type failures.

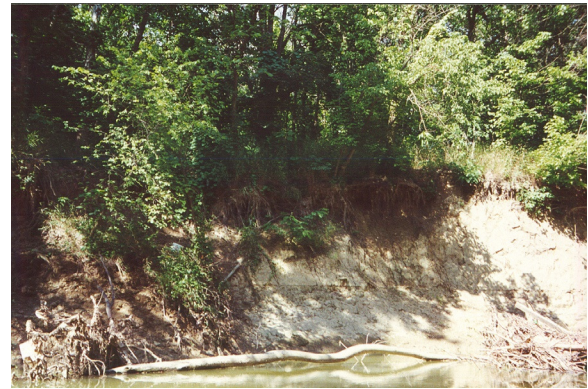
Examples of erosion on Banklick Creek are shown below in Figures 24 and 25.

Figure 24: Bank erosion due to localized scour

Localized erosion control along the banks could be accomplished with the use of live stakes consisting of Willow, Dogwood and Elderberry cuttings collected from nearby harvest sites along Banklick. For cost estimation purposes, approximately 1,000 live stakes harvested and installed with hand labor along the lower reach were considered. The actual number and location of live staking will need to be determined in the feasibility phase.

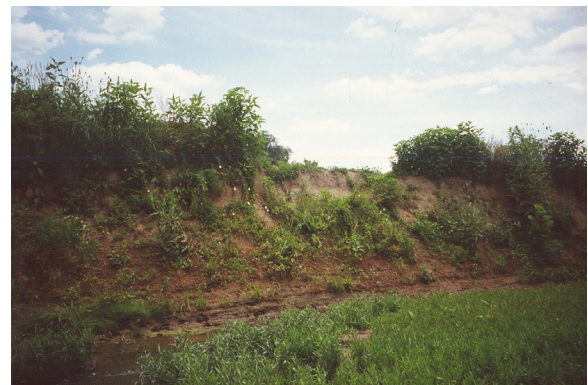
**Figure 25: Bank Erosion due to lack of
vegetation**

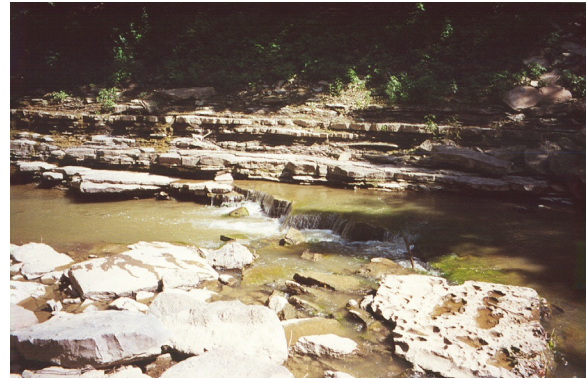
Figure 27: Headcut through bedrock

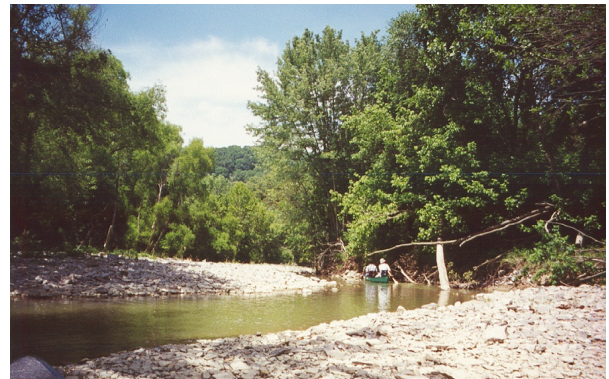
Figure 28: Cobble Point Bar Formation
